SAVARY ISLAND DUNE AND SHORELINE STUDY

Report

The Powell River Regional District

Thurber Engineering Ltd.
Vancouver, BC

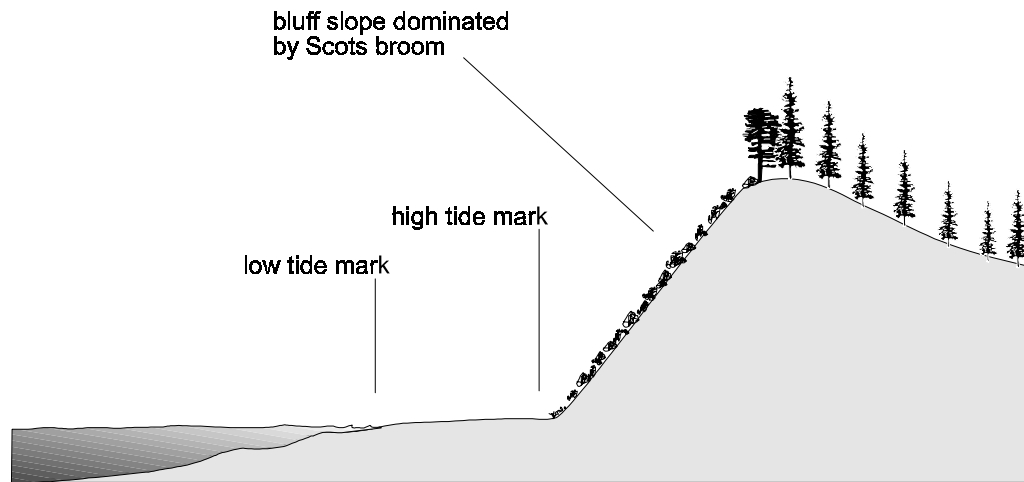
Figure 1. Cross sectional view east to west of South Beach, showing the easternmost portion dominated (and stabilized) by Scots broom.

Broom persists on the dry, open slopes where it has aided bank stabilization, but has resulted in low structural and floristic diversity, especially of native species (Figure 1). On the slopes above South Beach, numerous plants — mostly weed species — grow amongst and beneath the dense cover of Scots broom: field chickweed (*Cerastium arvense*), entire-leaved gumweed (*Grindelia integrifolia*), hairy cat's ear (*Hypochoeris radicata*), yarrow (*Achillea millefolium*), cleavers (*Galium aparine*), miner's lettuce (*Claytonia perfoliata*), sheep sorrel (*Rumex acetosella*), chickweed (*Stellaria media*), dovefoot geranium (*Geranium molle*), bull thistle (*Cirsium vulgare*), purple dead-nettle (*Lamium purpureum*), sweet vernalgrass (*Anthoxanthum odoratum*), orchardgrass (*Dactylis glomerata*), other grasses, and trailing blackberry (*Rubus ursinus*).

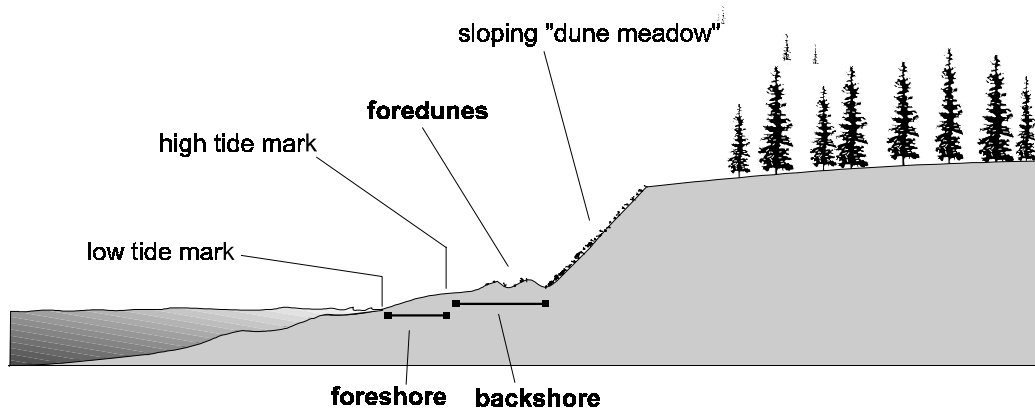
Figure 2. Cross sectional view east to west of the “dune meadows” on the steep slope overlooking the foredune just east of the east terminus of Sunset Trail (DG-2-G). This slope supports a great diversity of herbaceous plants (plus tall Oregon-grape) typical of foredune and coastline dune meadows.

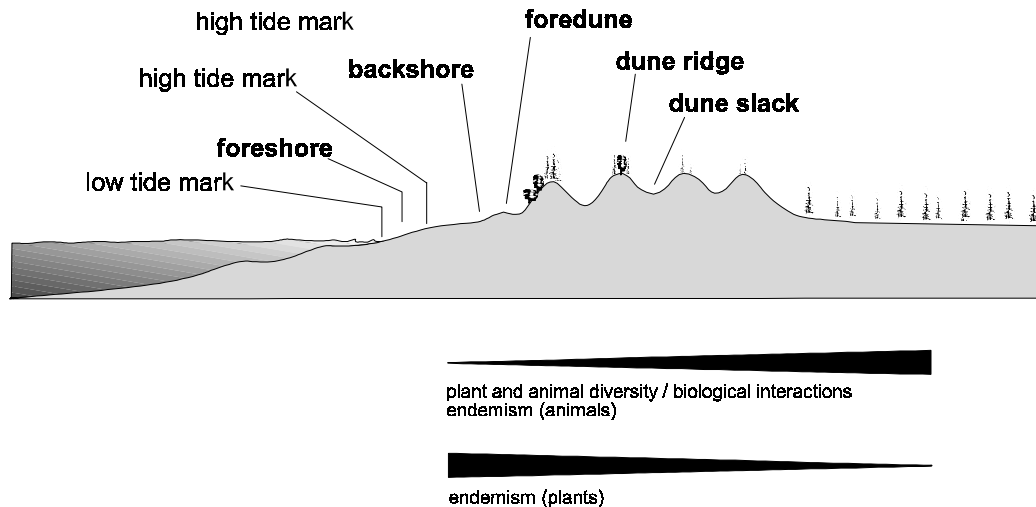
Figure 4. Cross sectional view from east to west of the inland dunes extending northeast from foredunes and dune meadows east of Beacon Point (DG-2-C,D). To illustrate the general configuration, the dunes in this diagram are represented as being parallel to the shoreline when they are actually aligned obliquely to the shoreline: the shoreline is oriented east-west, while the dunes are oriented southeast-northwest. The elongated triangles show trends (increasing or decreasing) in diversity, endemism and biological interactions along a gradient from foredunes/dunes to inland forests (after Brown and McLachlan 1990).

The ancient sand dunes are most fully developed in the centre portion of the island (Figure 4). They comprise one third of the area of Savary Island, or 150 ha (CDC 2002). The series of parallel ridges and slacks (depressions between ridges) are aligned along a southeast-northwest axis, following the alignment of the prevailing southeast winds. These dunes lie mainly within Lot 1375 but extend to and terminate in Lot 1376 to the northwest. The dune ridges reach a maximum elevation of 31 m above sea level. The greatest difference in elevation between dune ridges and adjacent slacks is approximately 20 m.

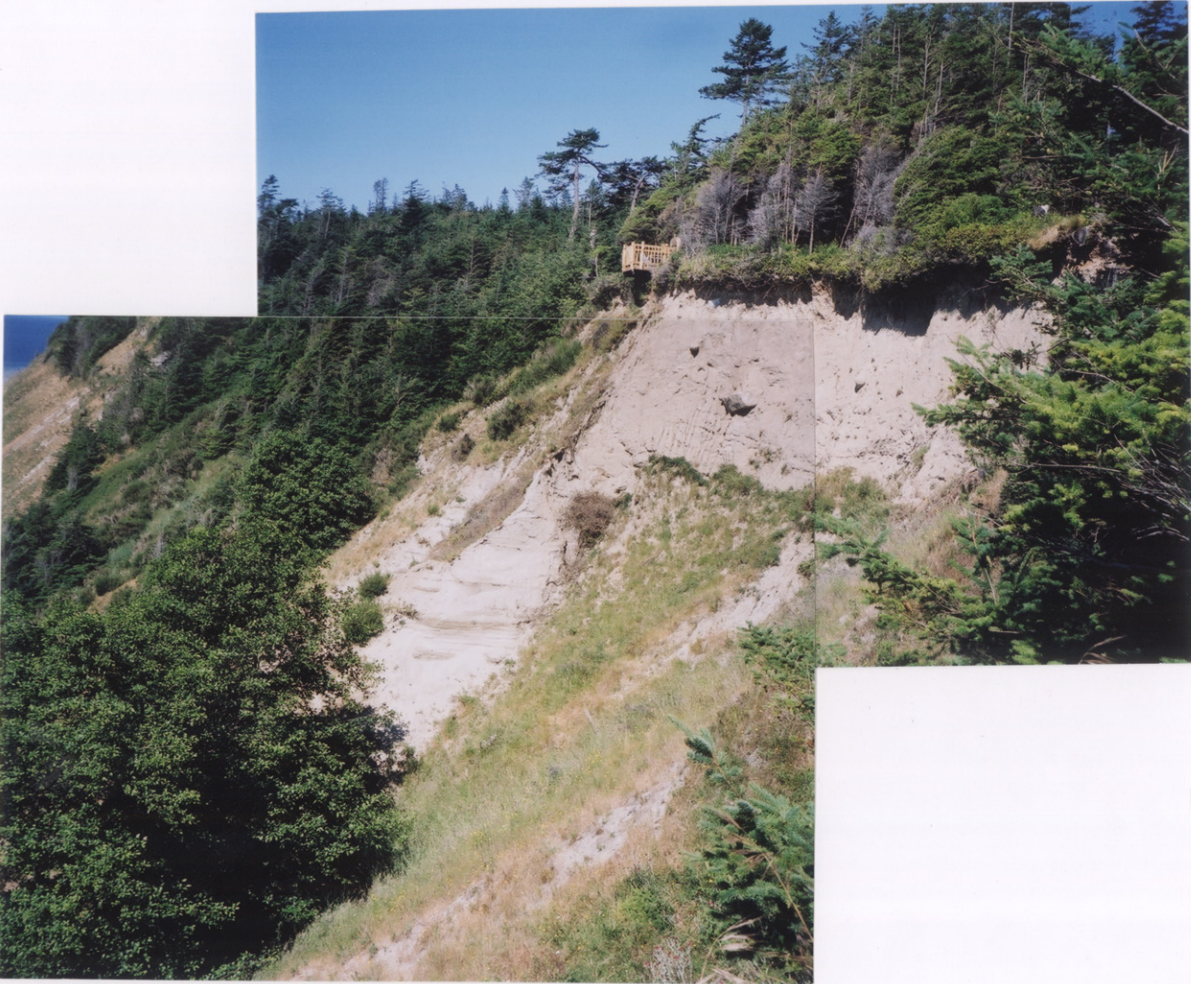
Photo 1 - Looking west along the south shore bluffs between Sutherland Road and Cunningham Road. Glacial drift with apparent boulder till-like soil forms a near-vertical face at the top of the bluff overlying beds of Quadra Sand.

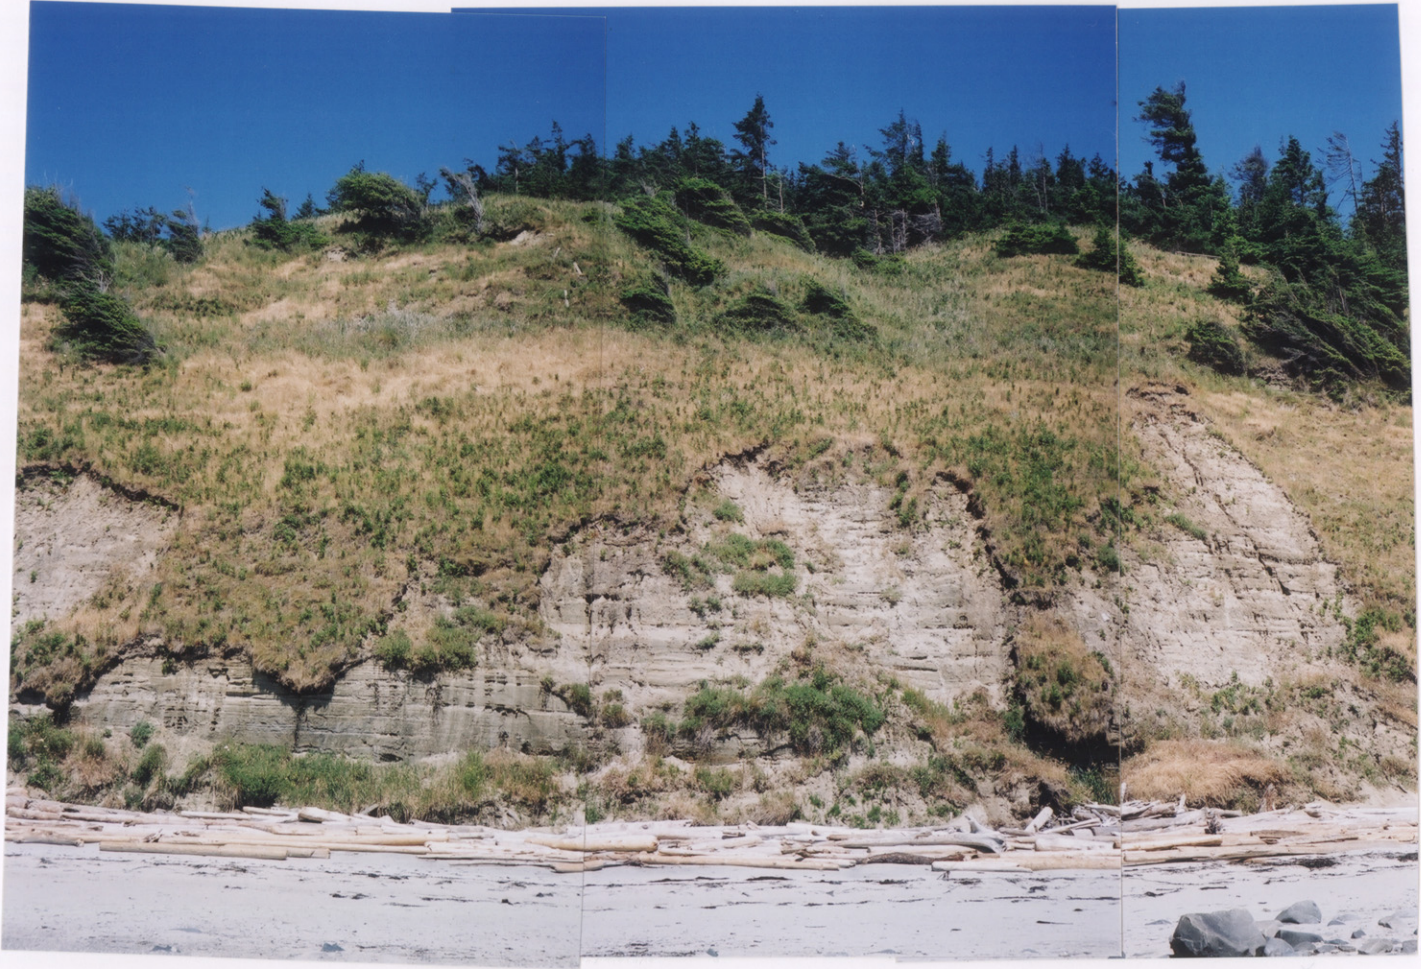
Photo 2 - Looking north at the south shore bluffs between McLean Road and Sutherland Road. Slumps and planar soil landslides are promoted by groundwater discharge in the Quada Sand. Lines of lush vegetation define seepage zones higher on the slope.

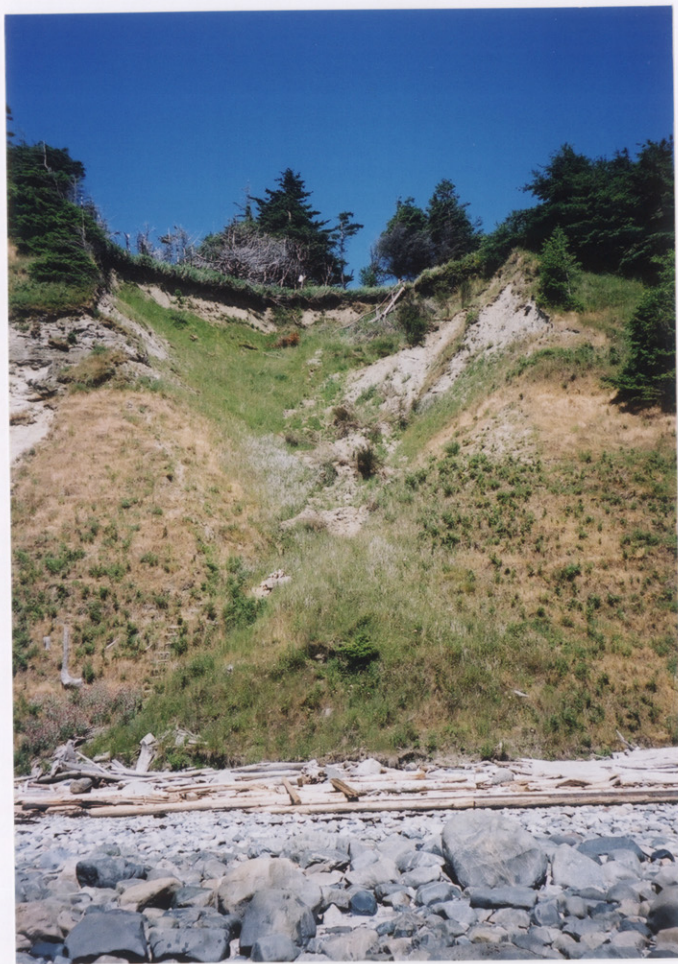
Photo 3 - Looking north at a gully on the south shore near the end of Sutherland Road. A recent slide has taken place, initiating on the east side of the gully head. Slide debris from past events has built up a debris cone at the base of the slope.

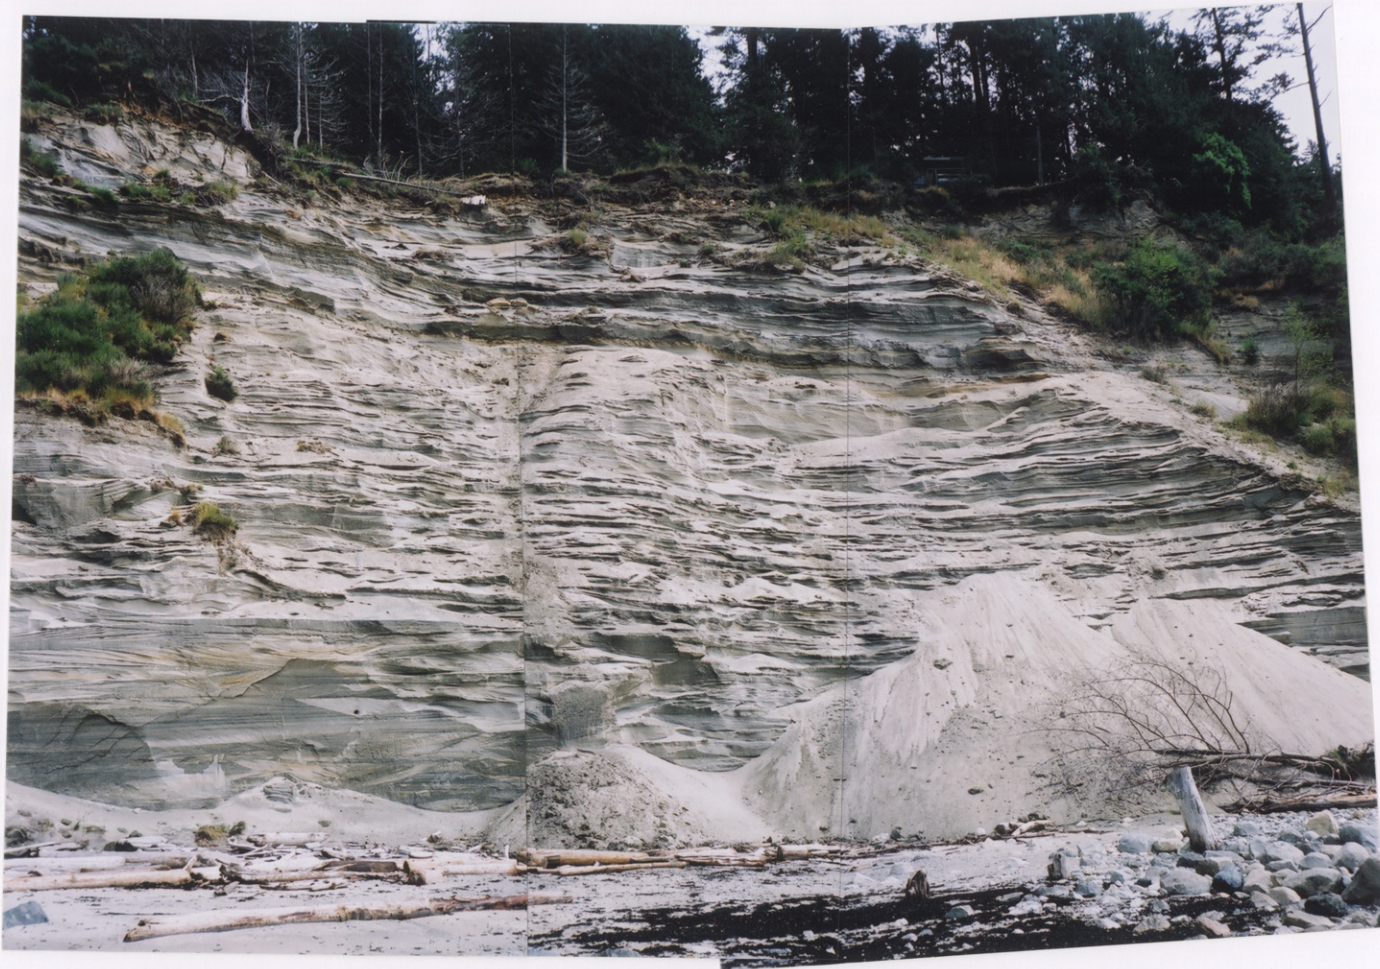
Photo 4 - Looking north at the erosion face in Quadra Sand on the west side of Garnet Point. Eroded sand accumulates at the base of the slope and is removed by wave action. Intense erosion here is ascribed to refracted storm waves from the southeast. The Geological Survey of Canada measured 0.38 m of bluff crest retreat in 1 year at this location.

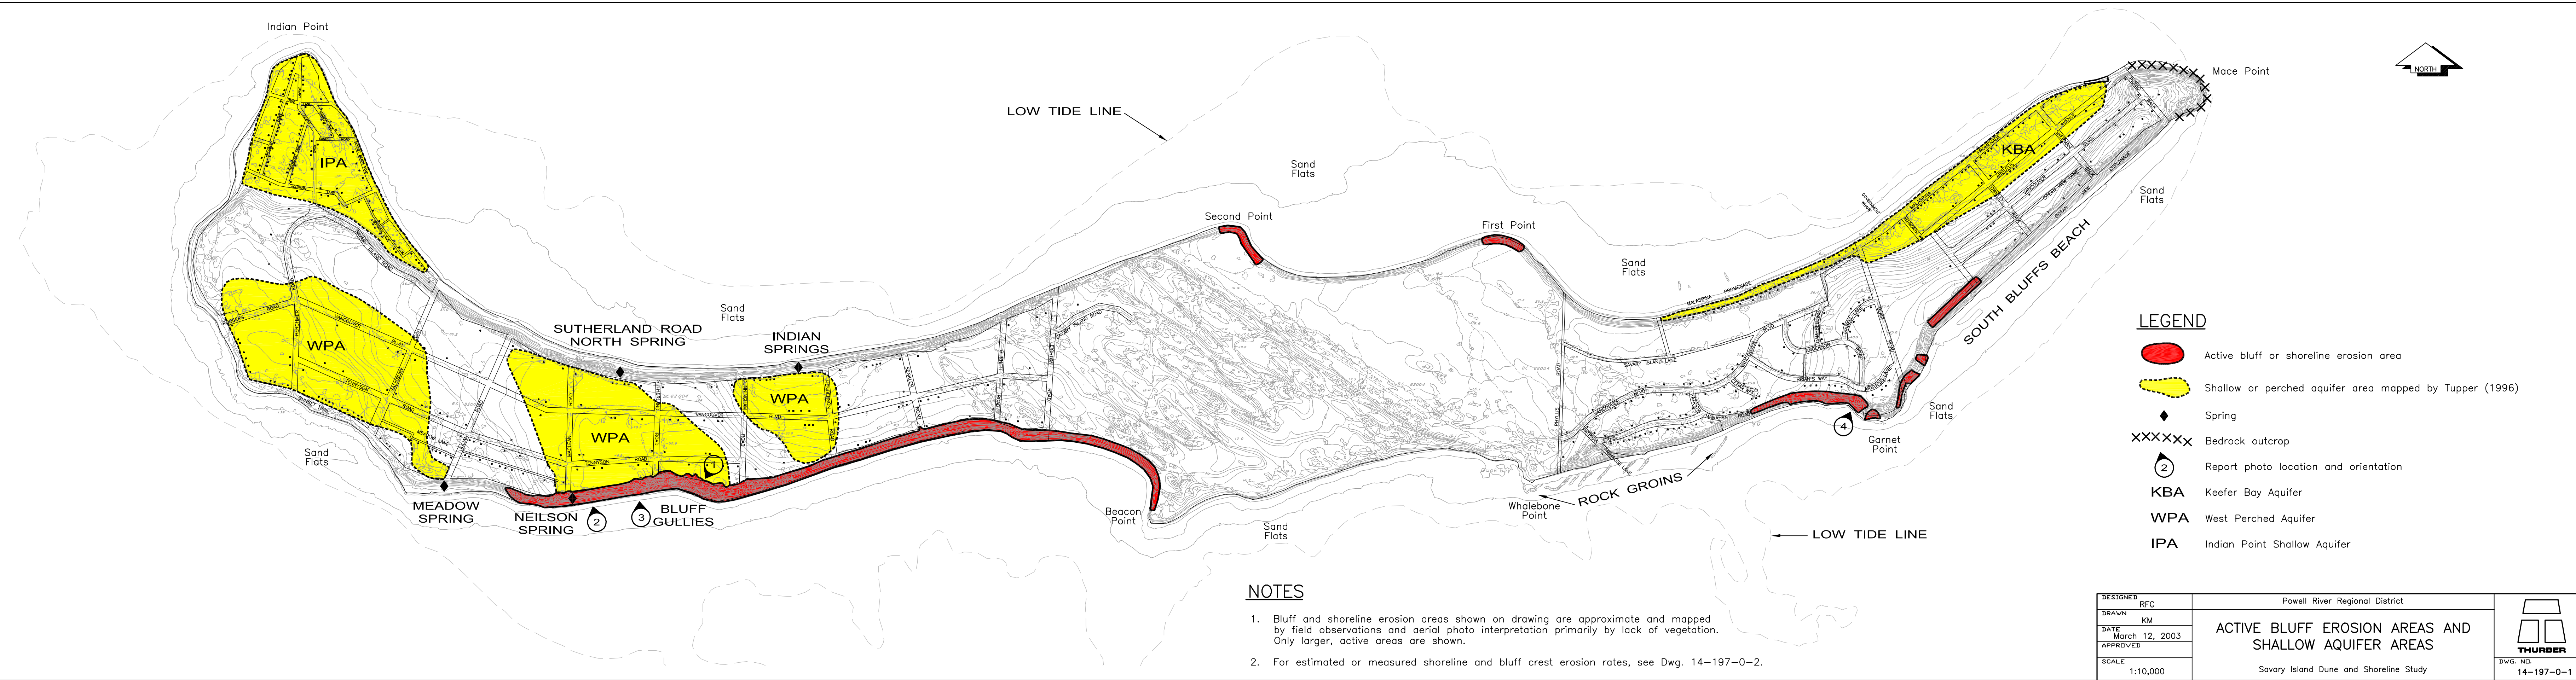
THURBER DWG. NO. 14-197-0-1
DRAWN KM	ACTIVE BLUFF EROSION AREAS AND SHALLOW AQUIFER AREAS	
DATE March 12, 2003		
APPROVED	Savary Island Dune and Shoreline Study	
SCALE 1:10,000

1. Bluff and shoreline erosion areas shown on drawing are approximate and mapped by field observations and aerial photo interpretation primarily by lack of vegetation. Only larger, active areas are shown.
2. For estimated or measured shoreline and bluff crest erosion rates, see Dwg. 14-197-0-2.

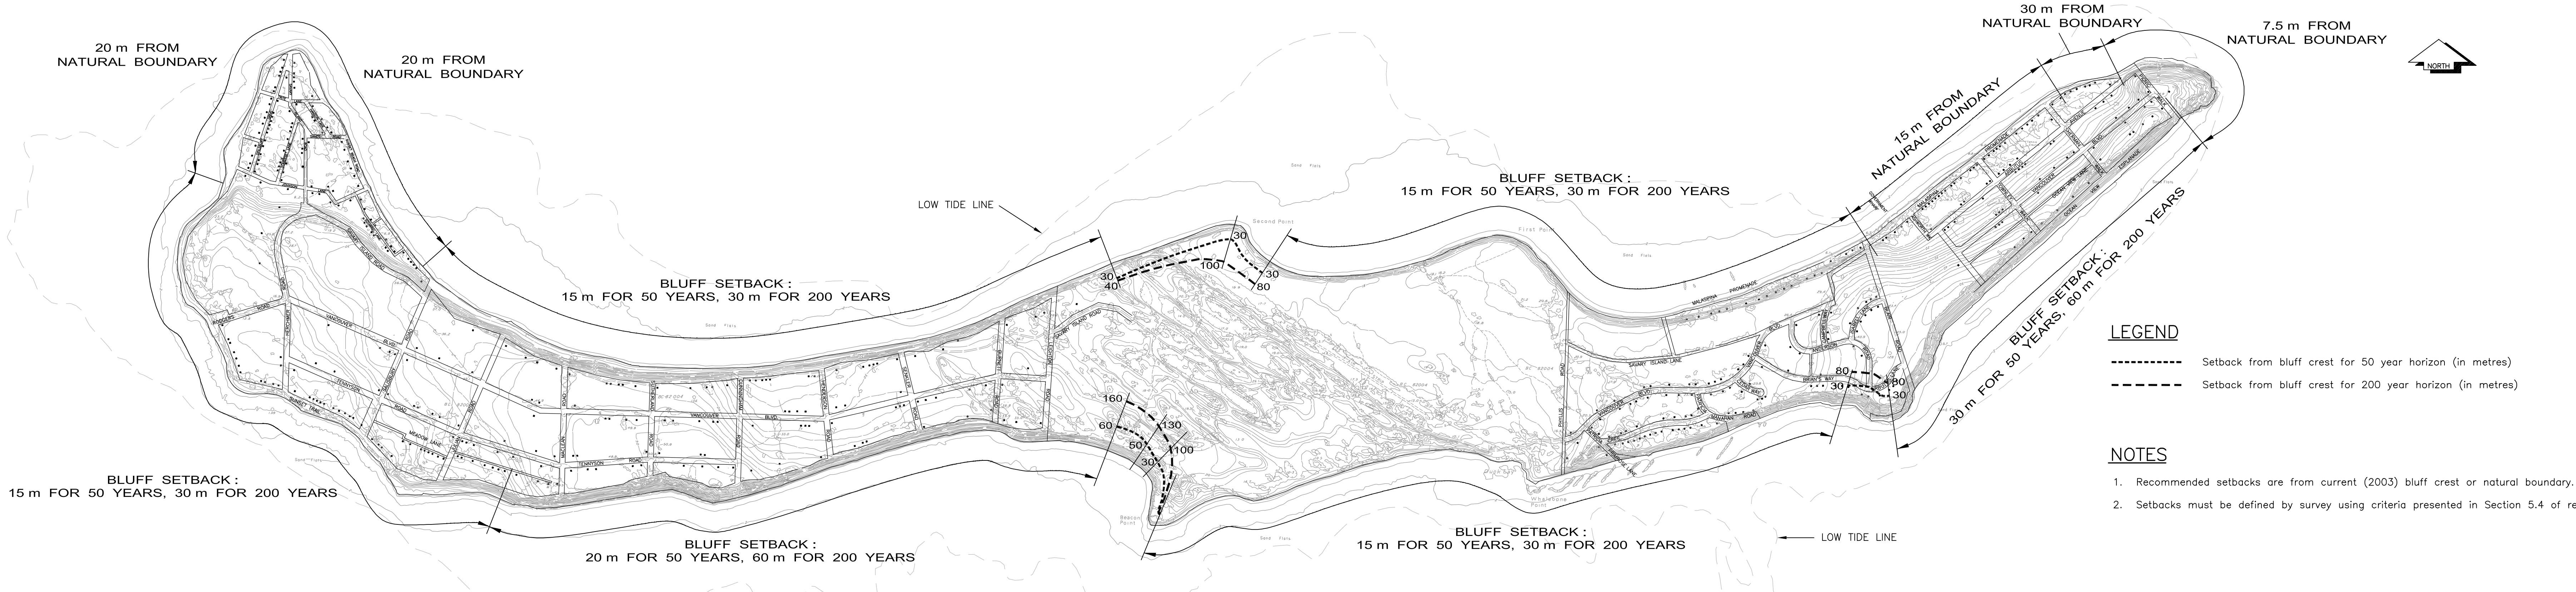
Building setbacks from the current bluff crest for 50 and 200 year horizons determined by application of the recommendations in Section 5.4 are shown on Dwg. 14-197-0-3. It should be recognized that the setbacks are preliminary and for guidance only. They assume that the current slope angle of the bluff is 40° and that the contours on the base plan accurately represent the bluff height. They should be defined in the field by survey of the bluff height and crest and consideration of the erosion which might have taken place since this report was prepared.

areas east of here is partially located in a bluff area where we recommend a 30 m wide bluff hazard area along the crest (Dwg, 14-197-0-3). If development is allowed in the area above Duck Bay, our judgment is that building setbacks from the natural boundary should be defined by the BC Land Act .

This area includes the relict dunes on the central Island. Part of the dune area west of Leighton Road is densely subdivided. Except in the area previously investigated by GAL in 1999 (Dwg. 14-197-0-3) our 15 and 30 m preliminary bluff slope hazard limits apply along the north and south shores. We do not necessarily endorse residential development on Inland dunes but, like comparable features in DG-2 areas, they are not distinctly hazardous.

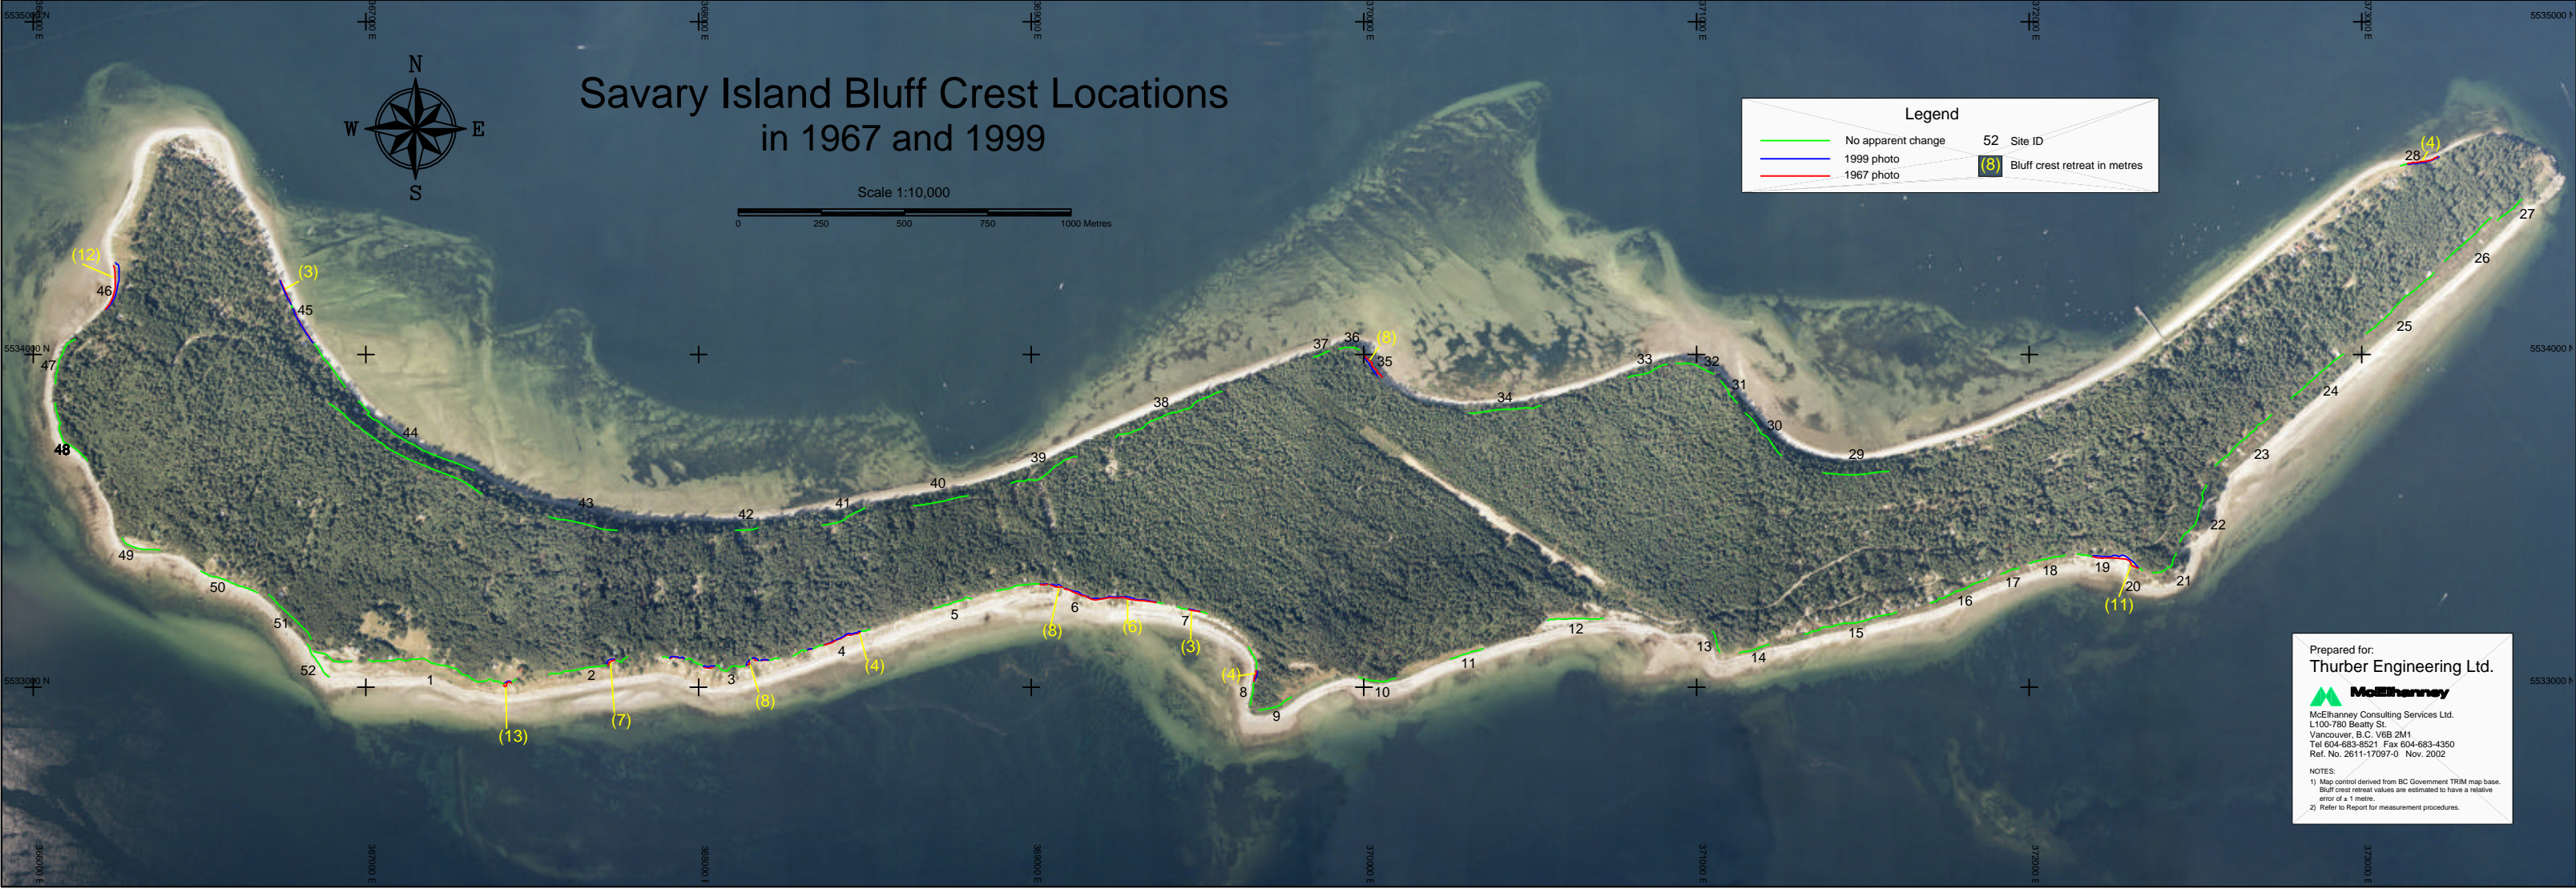
Legend			
—	No apparent change	52	Site ID
—	1999 photo	(8)	Bluff crest retreat in metres
—	1967 photo
